MAINTENANCE MANUAL

SHOREBIRD HIGHTIDE ROOST SITE KAKADU BEACH, NORTH HEADLAND, BRIBIE ISLAND

HLA-Envirosciences Pty Limited
25 September 2003
Project No R1180

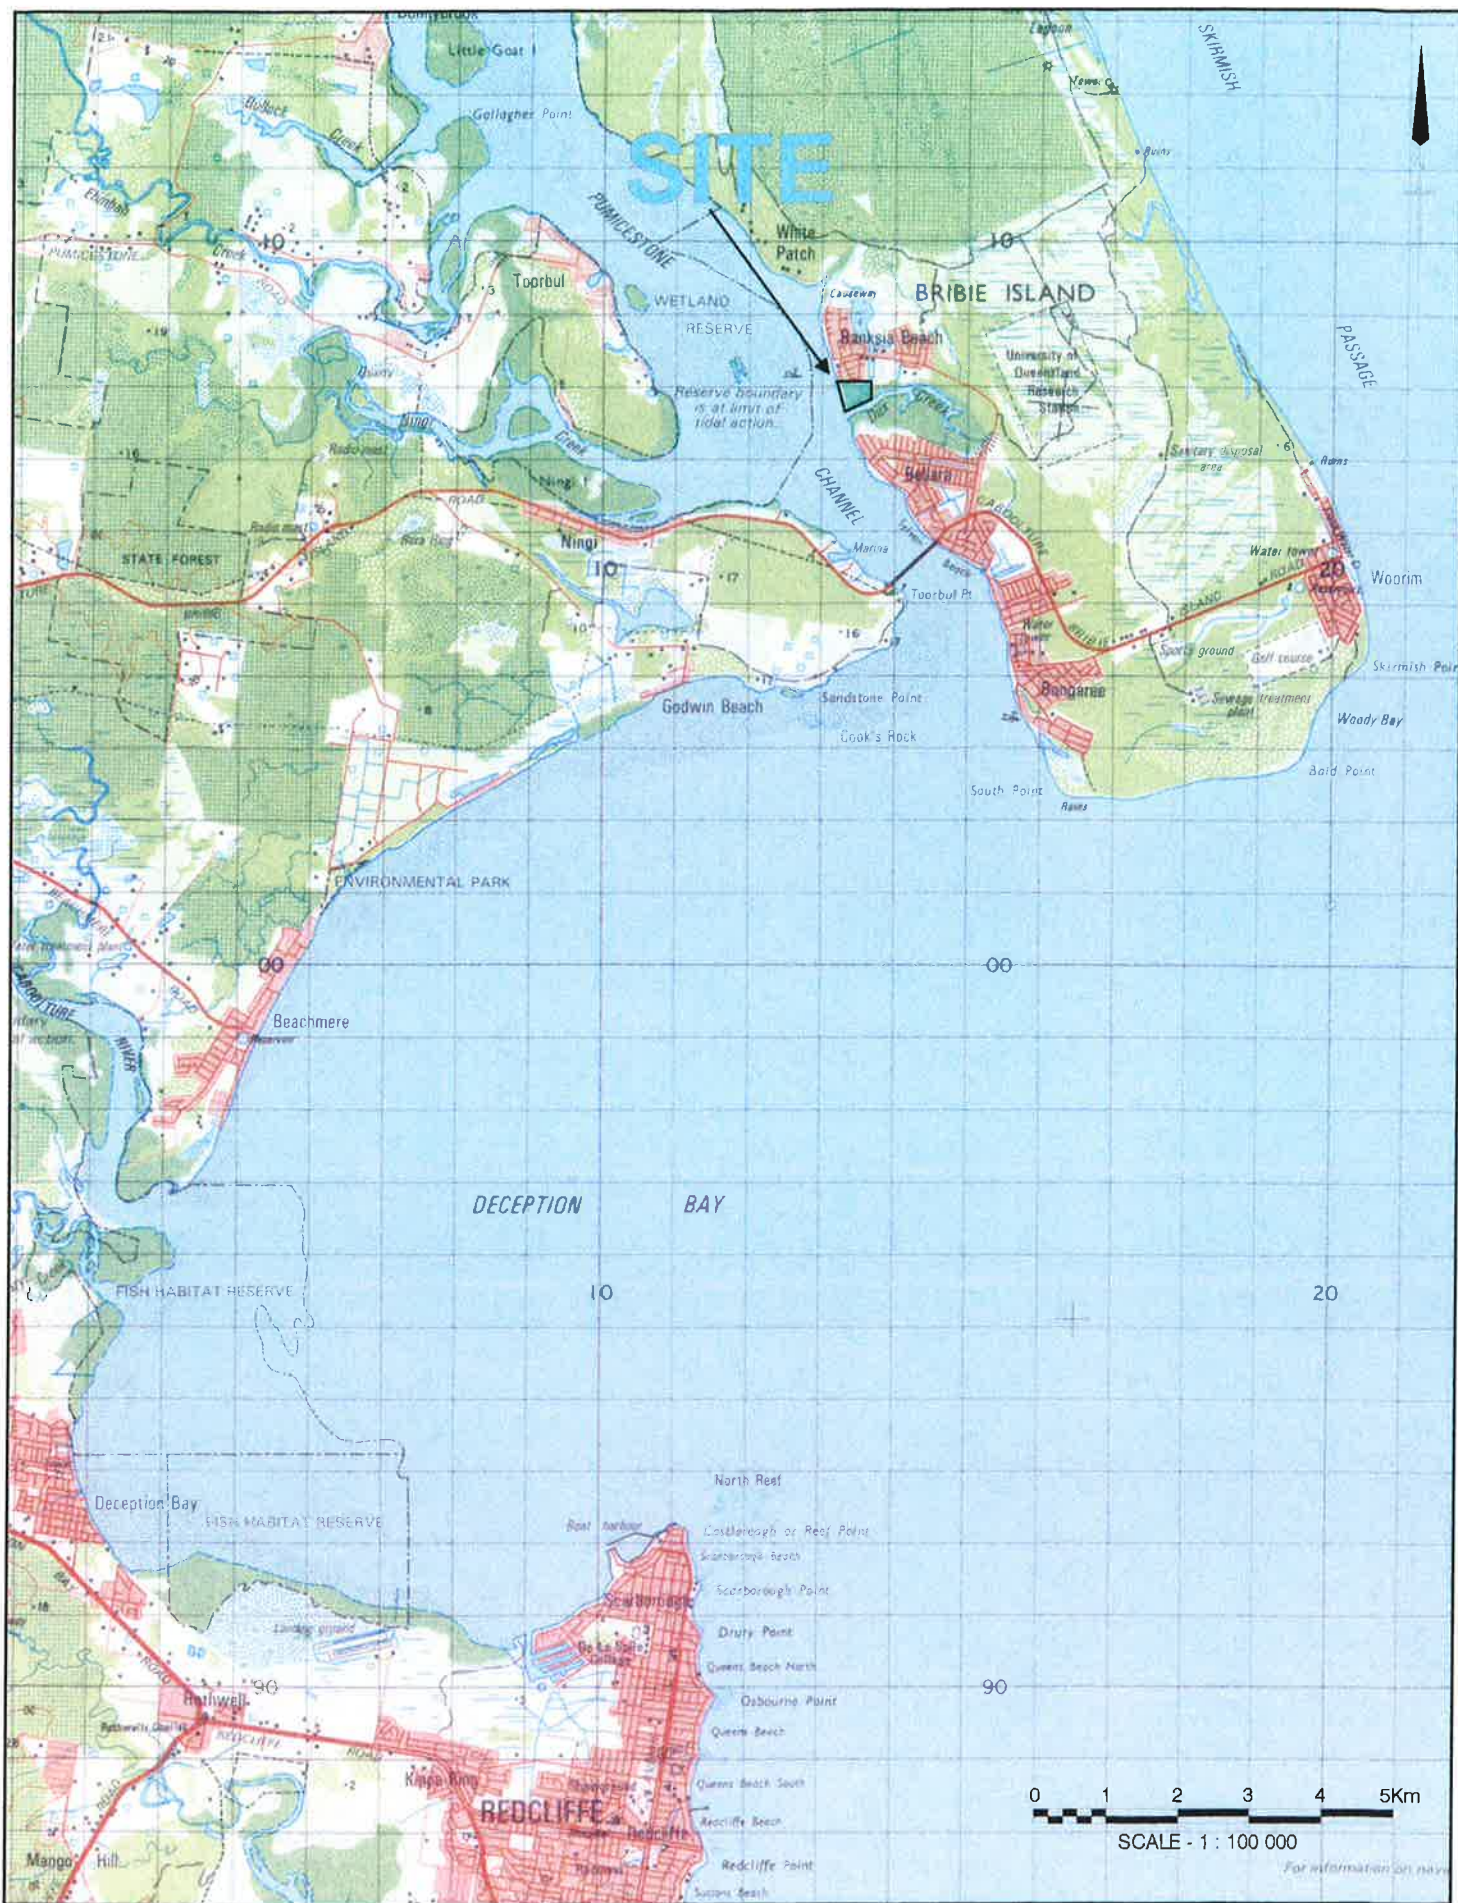
FIGURE
1.2

The area targeted by this manual is shown in **Figure 1.2** and includes the four areas described as 'Parkland', 'Lagoon', 'Shorebird Roost Site' and 'Beachfront'. An outline the philosophy behind each of these areas is provided below.

Site Plan

Inlet / outlet weir	<ul style="list-style-type: none"> • Location of weirs is shown on Figure 1.2. See Plate 7.
Lagoon water quality	<ul style="list-style-type: none"> • Maintain lagoon free of pollution (high turbidity, discolouration and / or odour, litter (particularly plastic products), hydrocarbons and surface debris. See Figure 8.
Gross pollutant traps	<ul style="list-style-type: none"> • Maintain free of debris. Location shown on Figure 1.2.
Lot boundary fencing	<ul style="list-style-type: none"> • Top fencing rail and uprights are aluminium fencing with black powder coating. • Fencing wire strands are stainless steel with stainless steel tension devices. See Plate 9.
Decorative timber posts within lot boundary fencing	<ul style="list-style-type: none"> • See Plate 9. • Timber is CCA treated HWF-17 with sand-ease edge and oil stain.
Dune fencing	<ul style="list-style-type: none"> • Posts are treated pine – 150 mm diameter. • Top railing is treated pine – 100 mm diameter. • Wire is 150 mm x 150 mm dog-proof fencing. See Plate 10. See Figure 1.2.

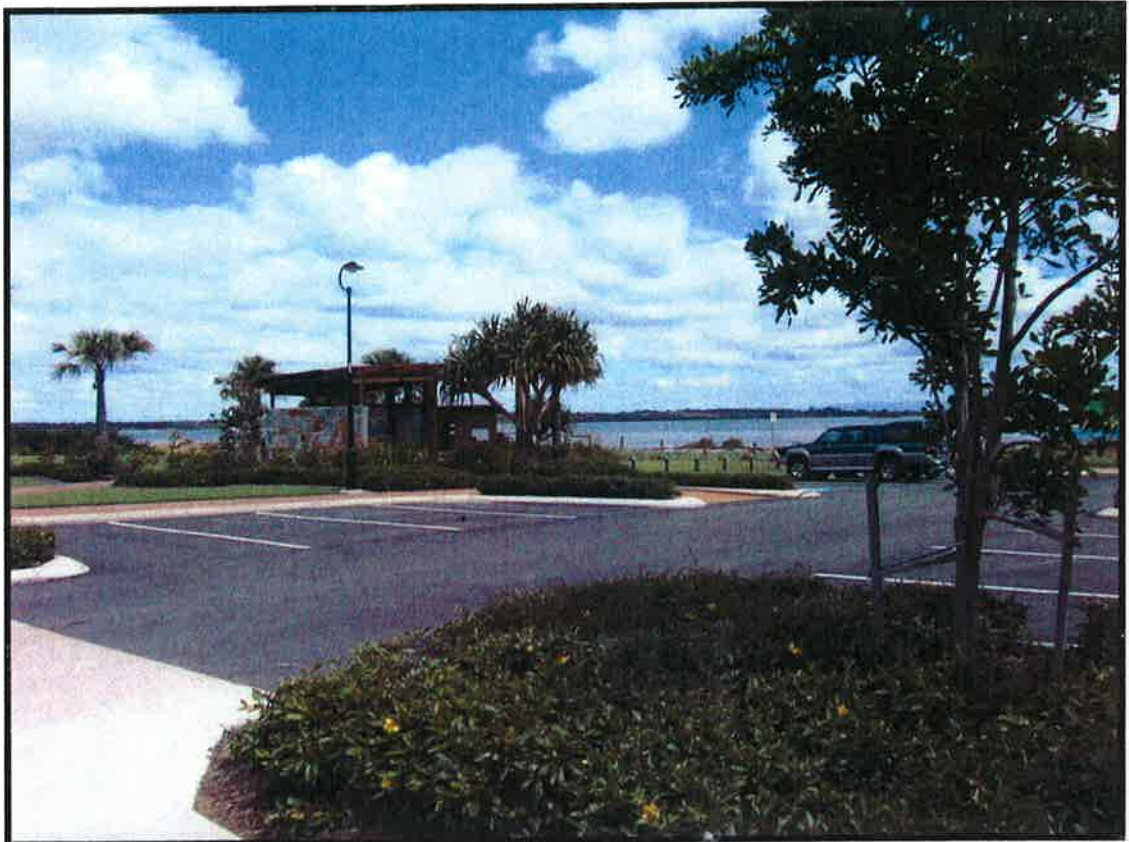
Plate 1. Northern car park and landscaped gardens.

WORK PROCEDURE SHEET 1 : MAINTENANCE OF PLANT HEALTH	
Issue	Procedure / Details
Objective	To maintain the health of the lawn and plants across the site. See Plates 1,2.
Insect infestations	<ul style="list-style-type: none"> • Insect populations are to be identified and monitored and damaging levels appropriately treated. • Properly trained management will be able to identify and assess insect infests/attacks and prescribe treatment to control damaging pests.
Diseases	<ul style="list-style-type: none"> • Plant diseases are to be identified and monitored and damaging levels appropriately treated. • Properly trained management will be able to identify and assess diseases and prescribe treatment to control damaging diseases. • The use of fungicides is prohibited in order to protect beneficial organisms.
Plants stunted/ deformed/abnormal colour	<ul style="list-style-type: none"> • The likely cause/s of abnormal plant growth is to be identified (e.g. excessive/inadequate watering regime, salt toxicity, nutrient deficiency/toxicity) and treated appropriately. • Establish and implement a management program to correct the disorder.

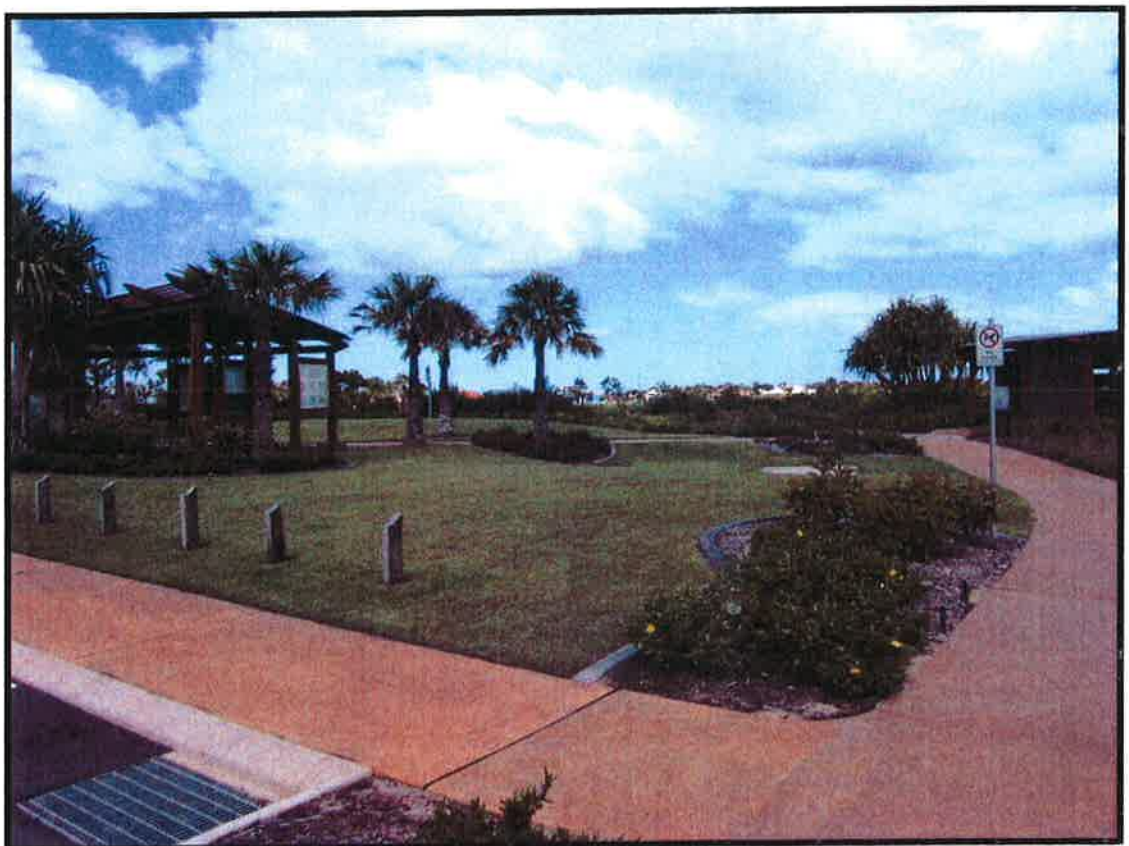
Plate 2. Turfed areas and landscaped gardens. Northern end of site.

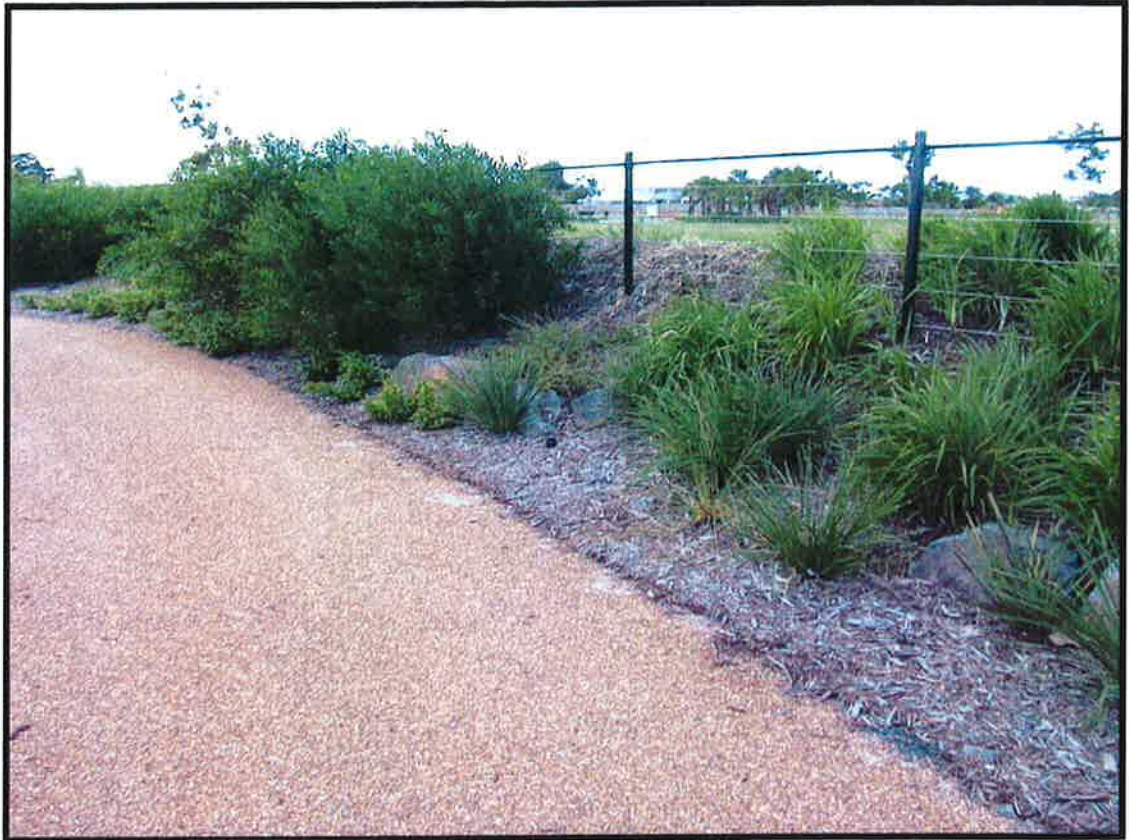
Plate 3. Mulched garden bed.

Issue	Procedure / Details
Mulching	<ul style="list-style-type: none"> • Re-application of mulch is required to maintain a 75 mm depth of mulch. Soil exposure is to be prevented. • Mulch is to shredded cypress mulch (hoop pine bark chips can be used as an alternative but the use of slash pine bark chips, forest mulch and sugar cane mulch is not recommended, but will be at the discretion of the managing party). See Plate 3.
Mangroves	<ul style="list-style-type: none"> • Mangroves are to be retained in an area no more than 40 m in length (20 m either side of the dune fence) at both the northern and southern ends of the shorebird roost site. See Figure 1.2. • All mangroves colonising the shorebird roost between these outcrops are to be removed annually between June and mid August prior to the arrival of shore birds. • Maintenance removal of mangroves and other debris is recommended in October, January and April using a hand plough and raking (only at low tide when bird visitation is at a minimum) • Section 51 <i>Fisheries Act</i> Permit Number 02SODB1634 authorises the removal of marine plants (mangroves) from the shorebird roost site.

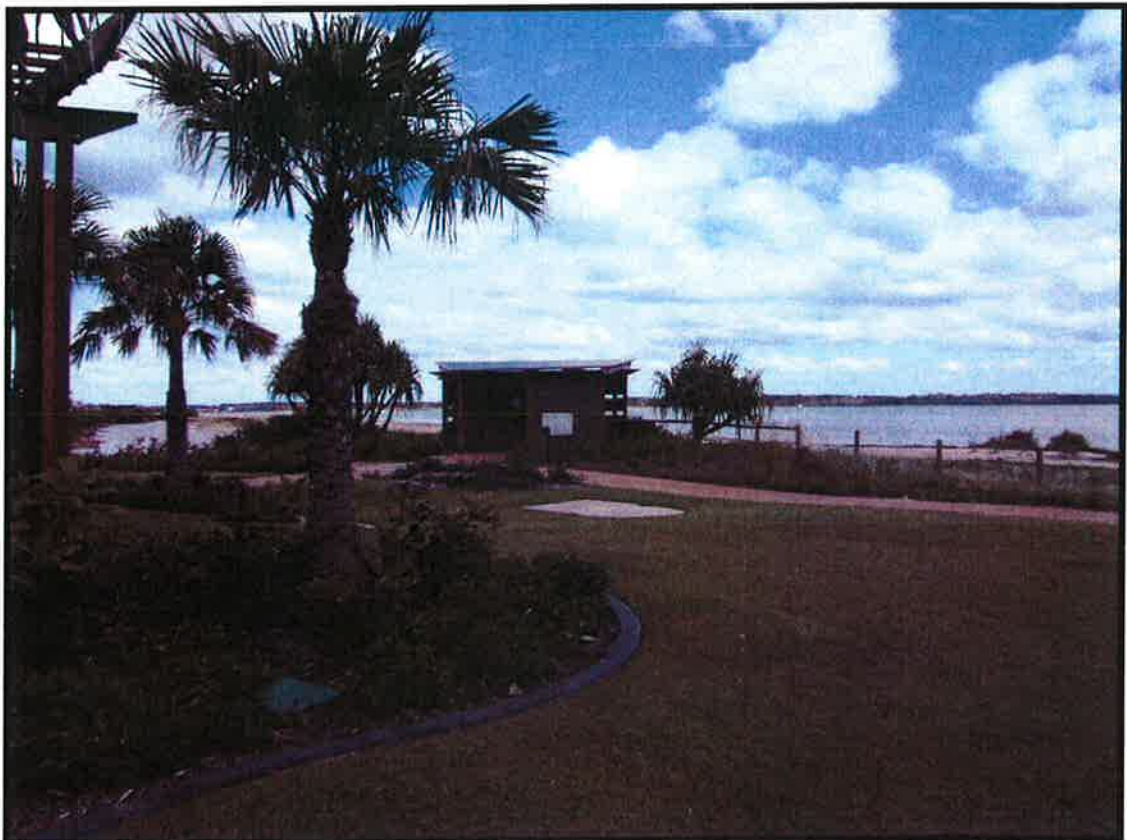
Plate 4. Green irrigation control box in foreground of photo. Northern end of site.

Issue	Procedure
Objective	To provide cost-effective irrigation to the landscaped gardens and lawn areas across the site
Location of watering points	<ul style="list-style-type: none"> • Approximately 20 valves are located across the site, generally adjacent to the pathways, and located within green sunken boxes. See Plate 4.
Frequency of watering	<ul style="list-style-type: none"> • Watering of plants is to be undertaken as required. • Watering of plants is to vary seasonal depending on rainfall and specific plant requirements. In rainfall periods, the requirement for watering is to be based on soil moisture conditions. • The water pressure dictates that only 4 valves can be operated at any one time.
Timing of watering	<ul style="list-style-type: none"> • The preferred timing for watering is just after dark in Spring and Summer and in the early mornings in Autumn and Winter. Watering outside these times will be less effective due to increased evapotranspiration. • Watering should be undertaken outside of high visitation periods to ensure visitor access to the site is not hindered.

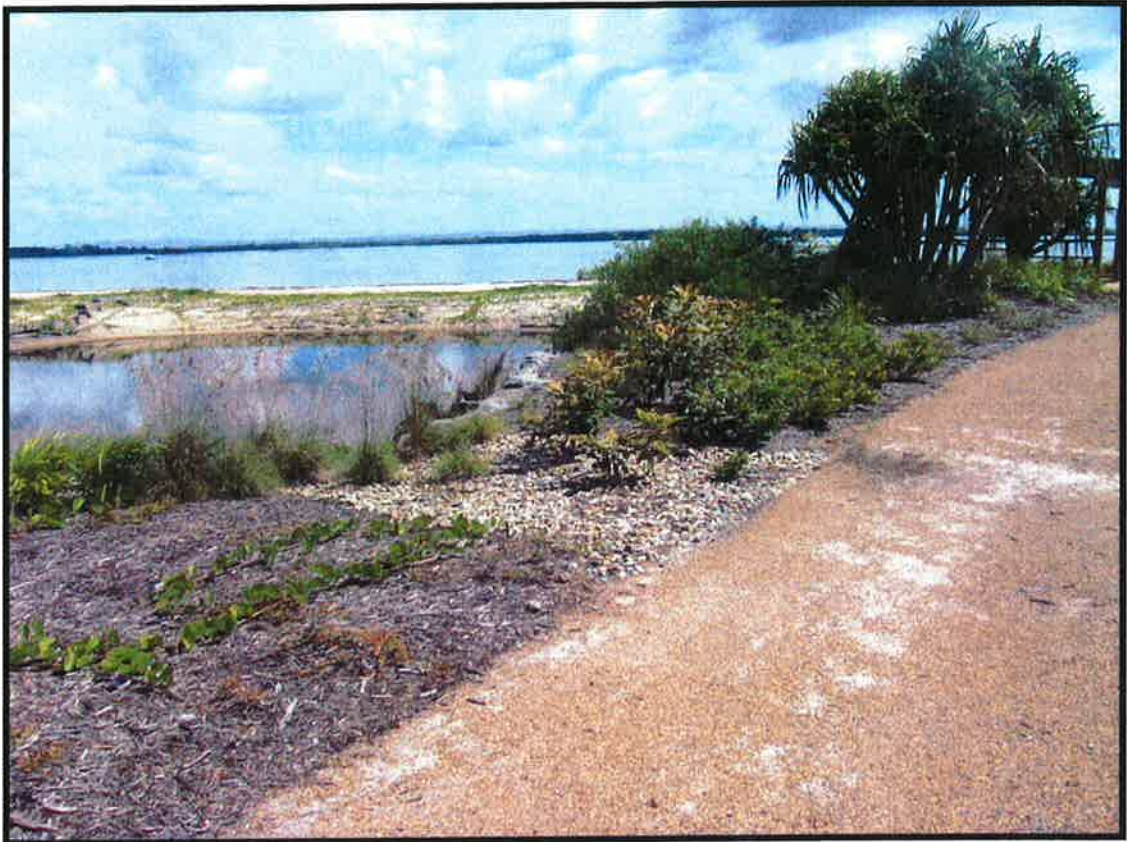
Plate 5a. Use of rocks in the garden bed to dissipate the energy of runoff water in selected areas of the site. Northern end of lagoon.

Issue	Procedure
Objective	To maintain the appearance and function of the existing infrastructure and to maintain the key landscape characteristics that promote a useable high tide shorebird roost site.
Erosion control	<ul style="list-style-type: none"> • No 'hard' engineering erosion and control structures are to be used (eg. grouted rock, pumped concrete mattresses, paved low flow channels etc). • Control measures are to be 'soft' engineering structures such as loose angular rock (See Plate 5) erosion / jute matting, plantings with suitable species such as <i>Lomandra</i>. • The guiding principle for erosion and sediment control at the site is to slow flow velocities.
Stormwater drainage	<ul style="list-style-type: none"> • Drainage layout plan is provided in Appendix D.
Sand accretion	<ul style="list-style-type: none"> • Earthworks to maintain 1:50 grade for the shorebird roost beachfront must not occur between the months of September and March inclusive. See Plate 6.

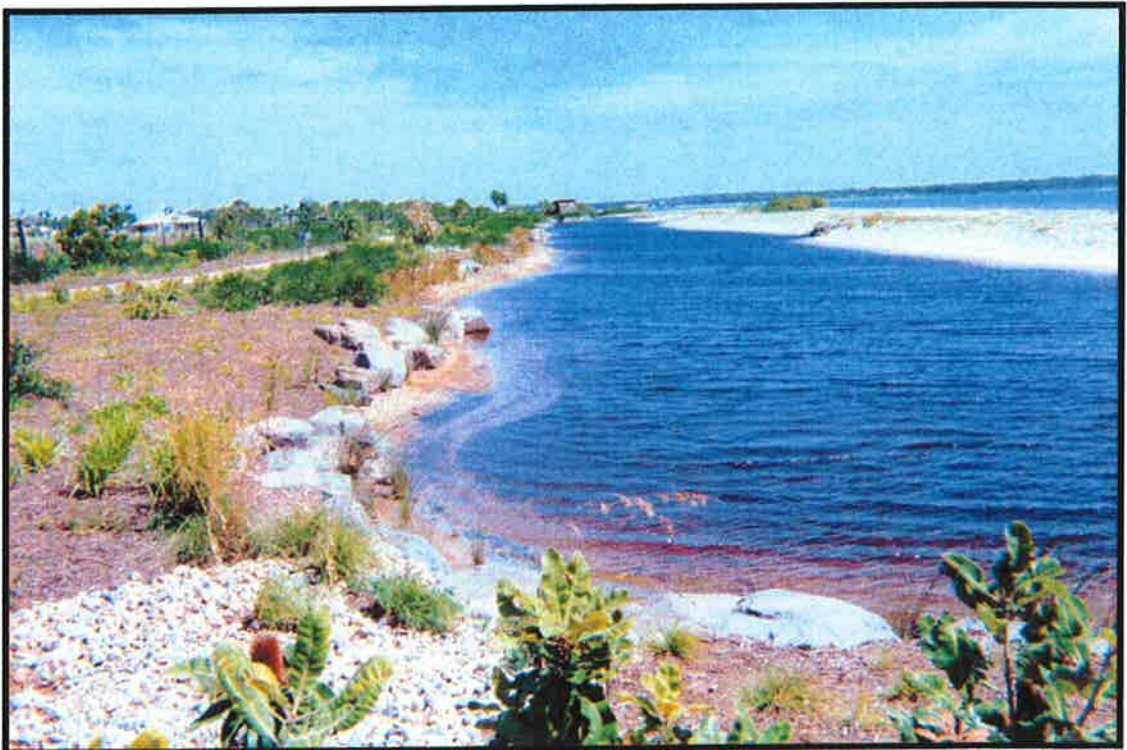
Plate 5b. Use of rocks as erosion control in selected areas around the lagoon margin. View looking south along the lagoon.

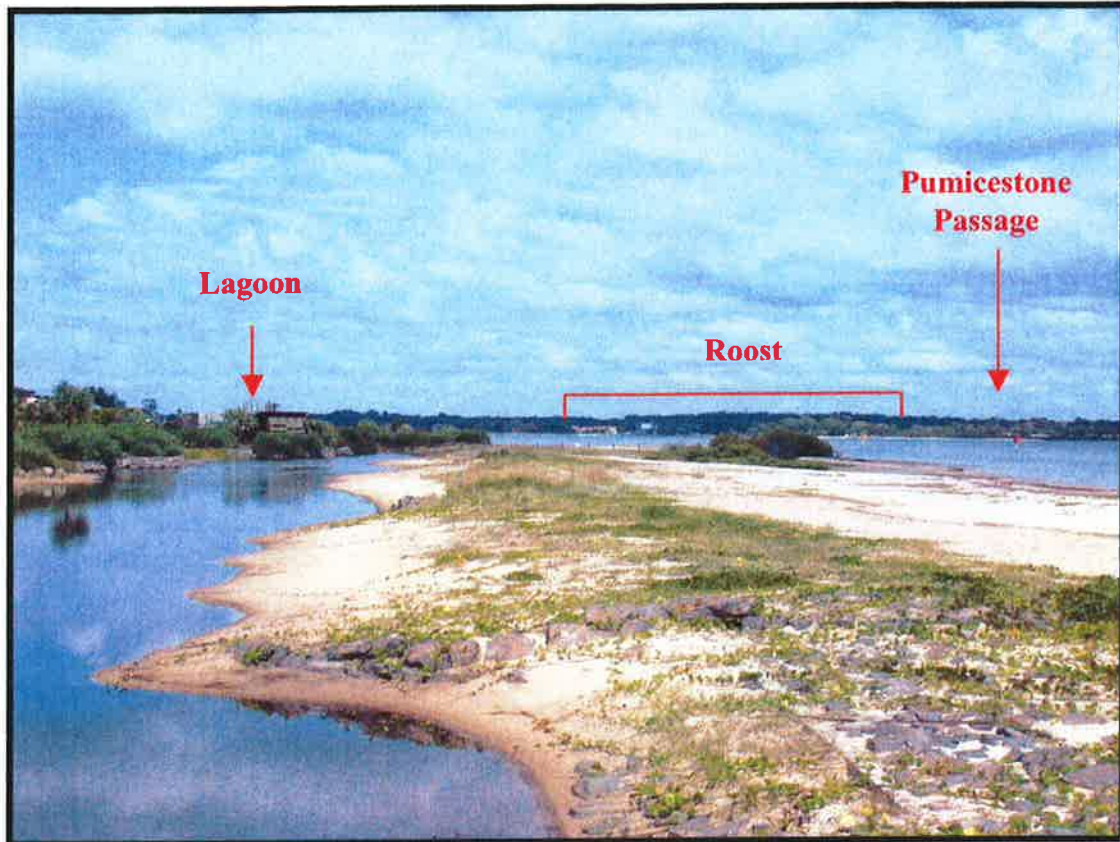
Plate 6. 1:50 slope of the shorebird roost site towards the Pumicestone Passage.
View looking south along the roost site.

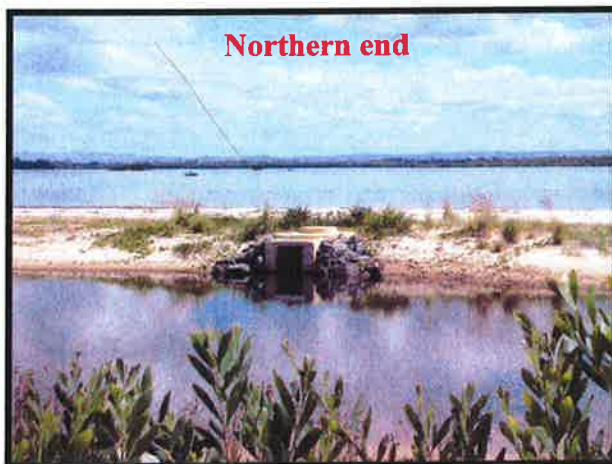
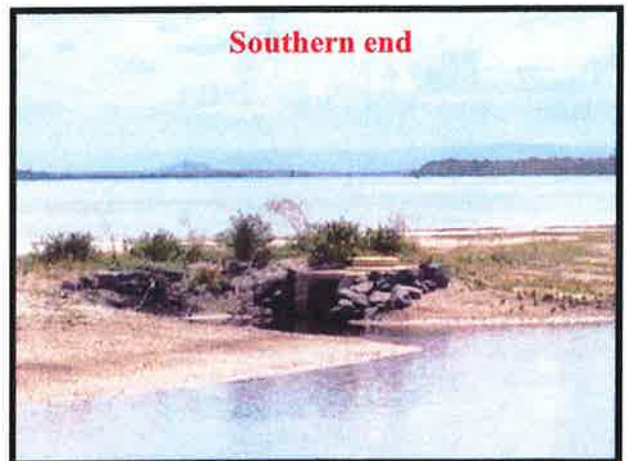
Plate 7. Inlet / outlet weirs on the western bank of the lagoon.

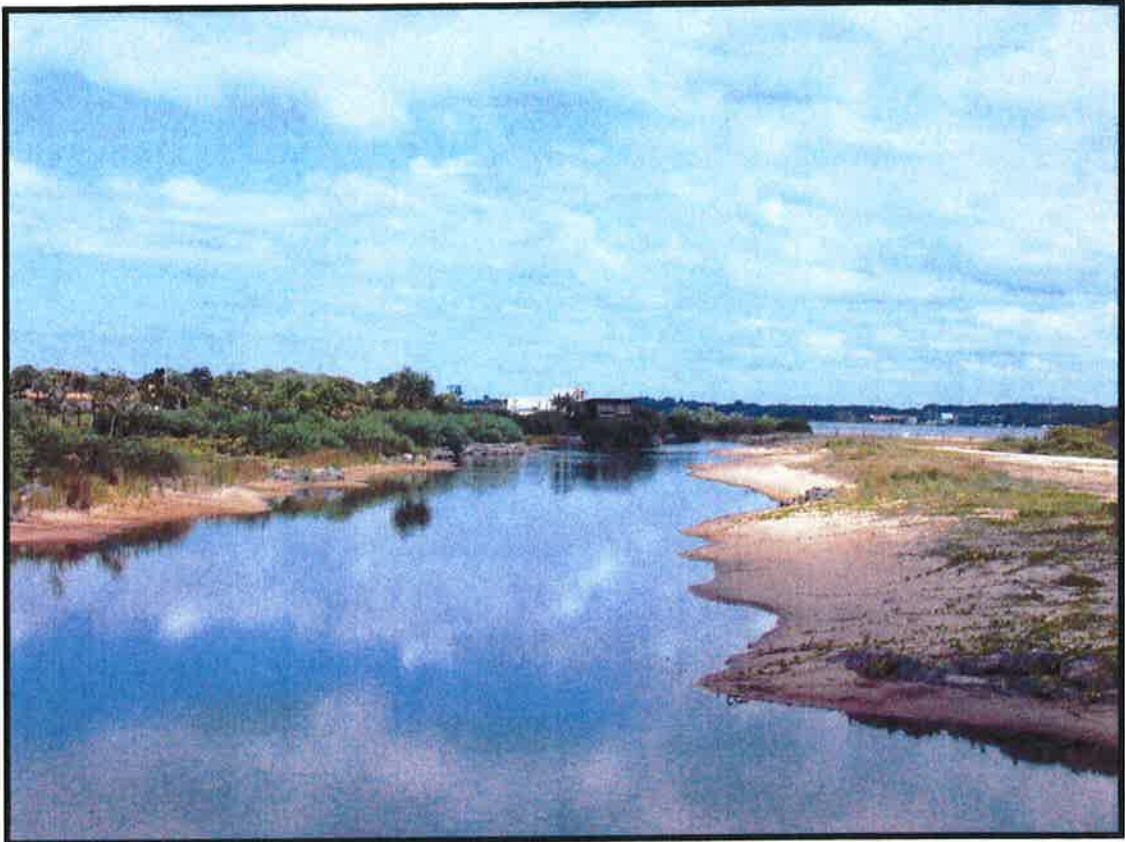
Plate 8. Lagoon water and banks must be kept free of pollutants.
View looking south.

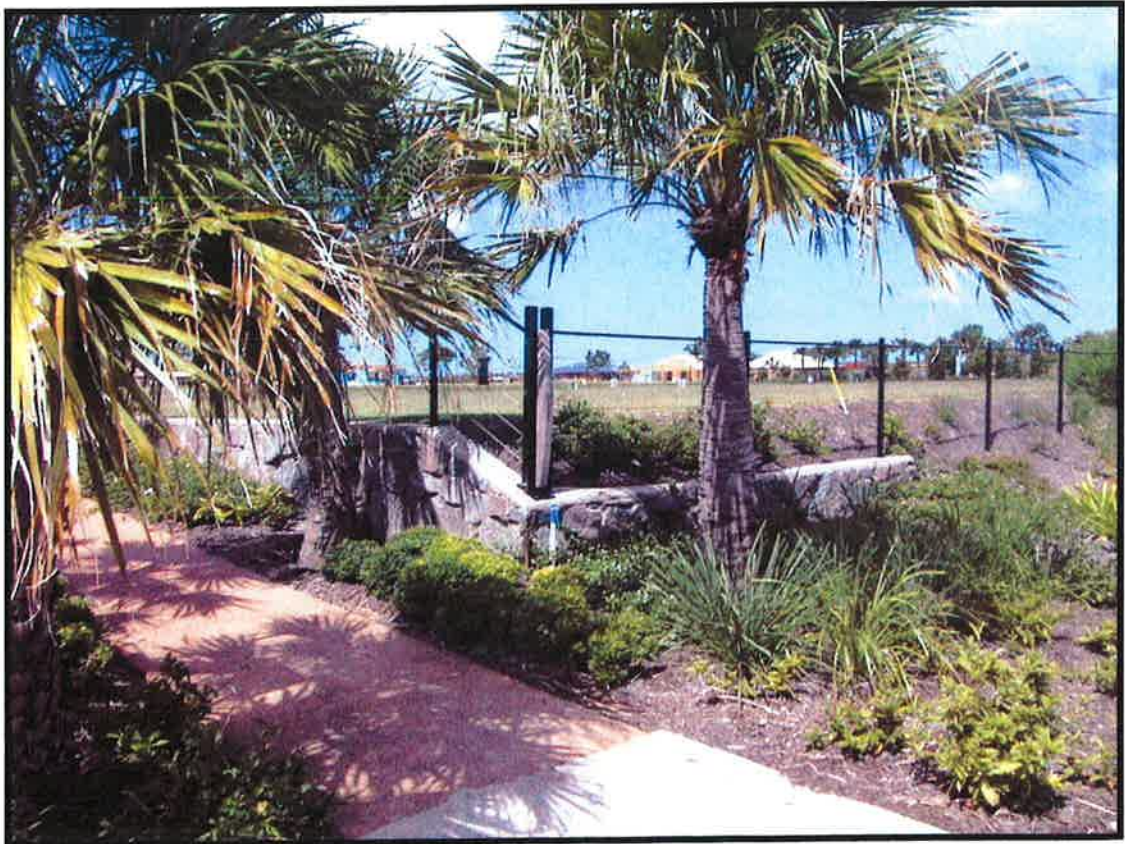
Plate 9. Lot boundary fence.

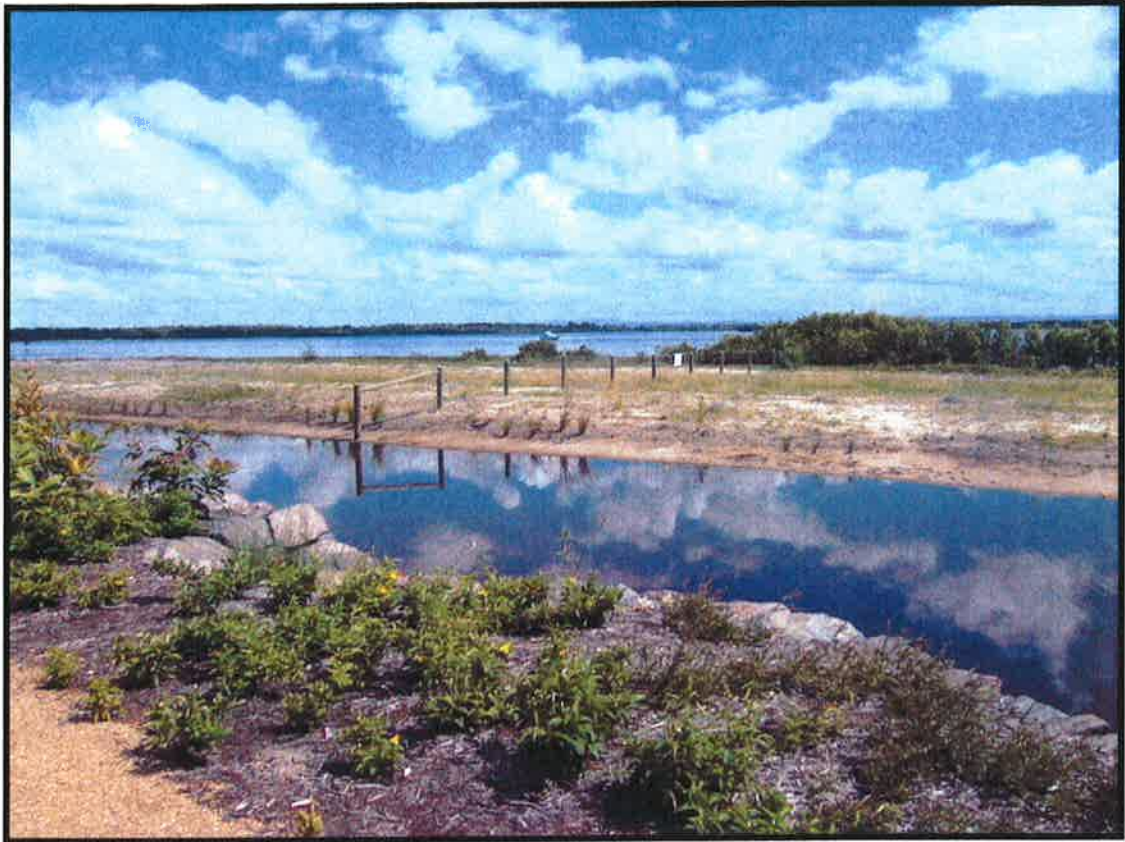
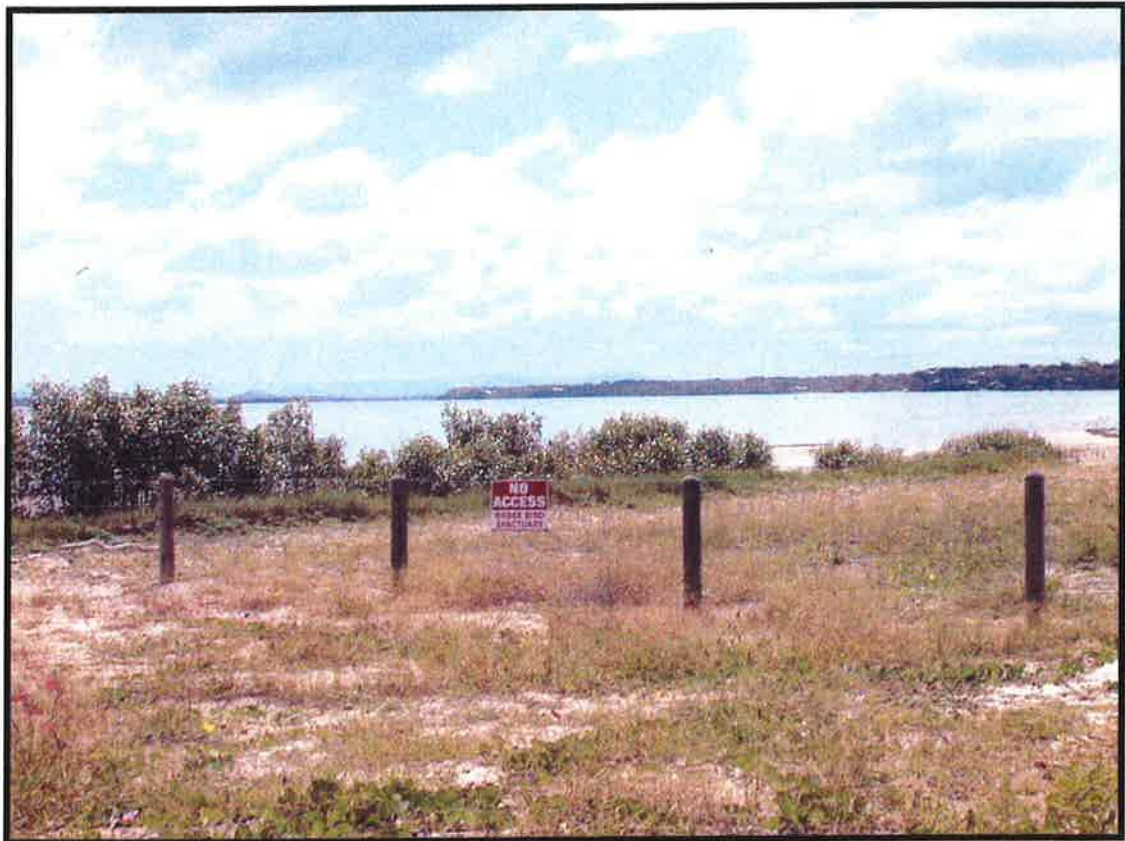
Plate 10a,b. Dune fencing delineating the boundary of the shorebird roost site.
View of the southern boundary fence.

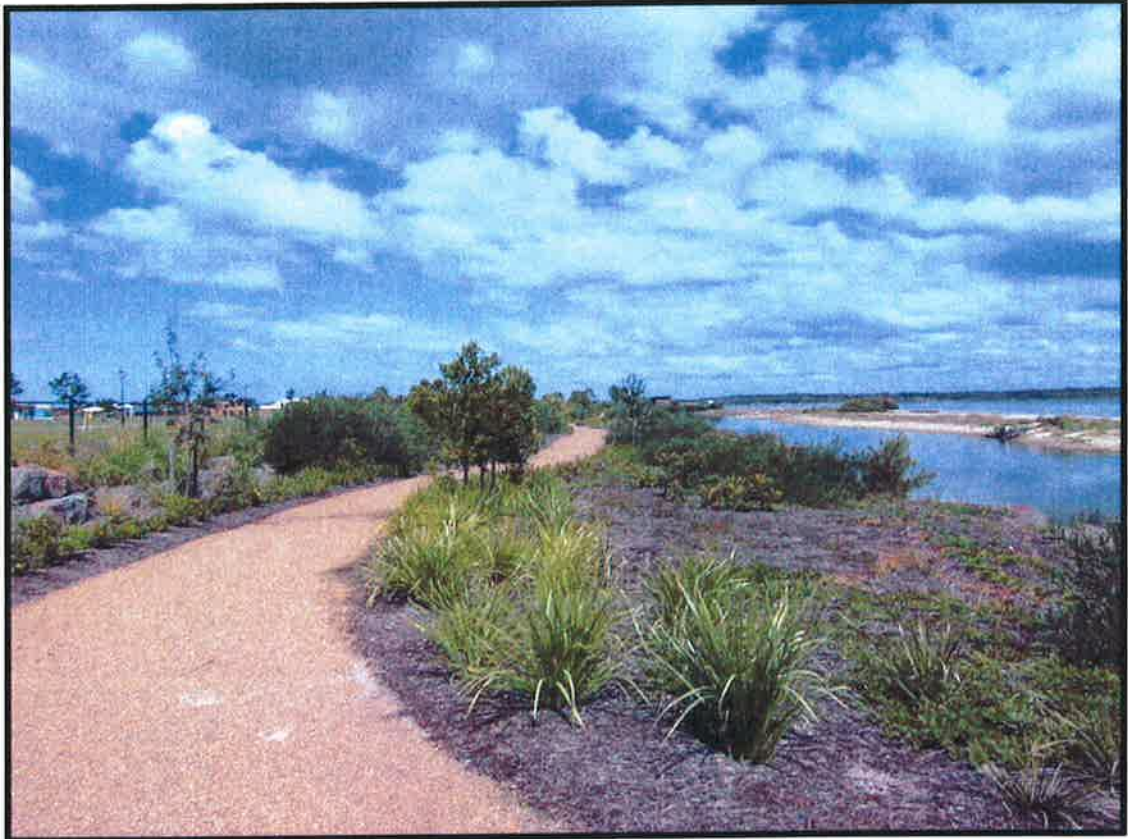
Plate 11. Compacted road base pathway through the parkland. View looking south.

Stone entry walls	<ul style="list-style-type: none"> • Paint for capping on stone entry wall is Dulux Olive Ochre – Code P16.C7. See Figure 1.2.
Pathways	<ul style="list-style-type: none"> • Pathways are compacted 100 mm minimum depth road base with a two coat spray seal. See Plate 11. See Figure 1.2. • Timber decking sections used 50 x 150 mm F14 CCA treated HW decking with sanded finish - ease edges and two galvanised screws per attachment. • Pavers associated with timber decking and entrance to interpretative exhibit are 200 x 400 x 40 mm and 400 x 400 x 40 mm respectively Urbanstone Pavers in 'Topaz' with a shotblast finish. • Pathways are to be kept free of rubbish, sand and soil.
Garden beds	<ul style="list-style-type: none"> • A maximum grade of 1:3 is to be retained in garden planting areas. See Plate 1. • Garden edges are 8.3% by weight 'Grey cement' and coloured Abilox Charcoal.
Interpretative exhibits	<ul style="list-style-type: none"> • See Plate 12. See Figure 1.2. • Structure paint is Dulux 'Olive Ochre' - Code P16.C7. • Base of columns are 'Grey cement'. • Timber is seasoned hardwood of single species F17, durability class 1 and painted with 2 coats of clear finish coating.

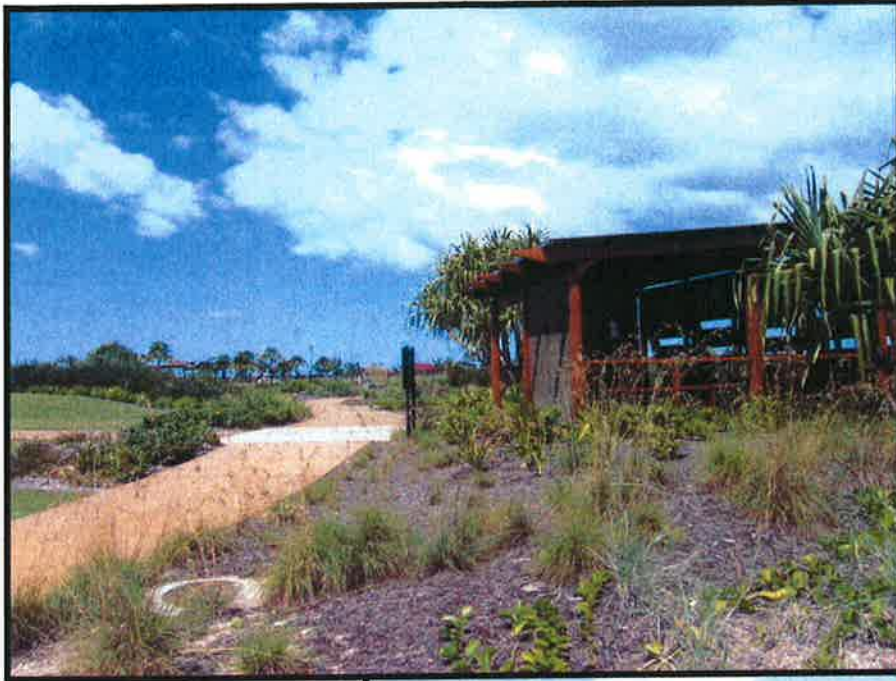
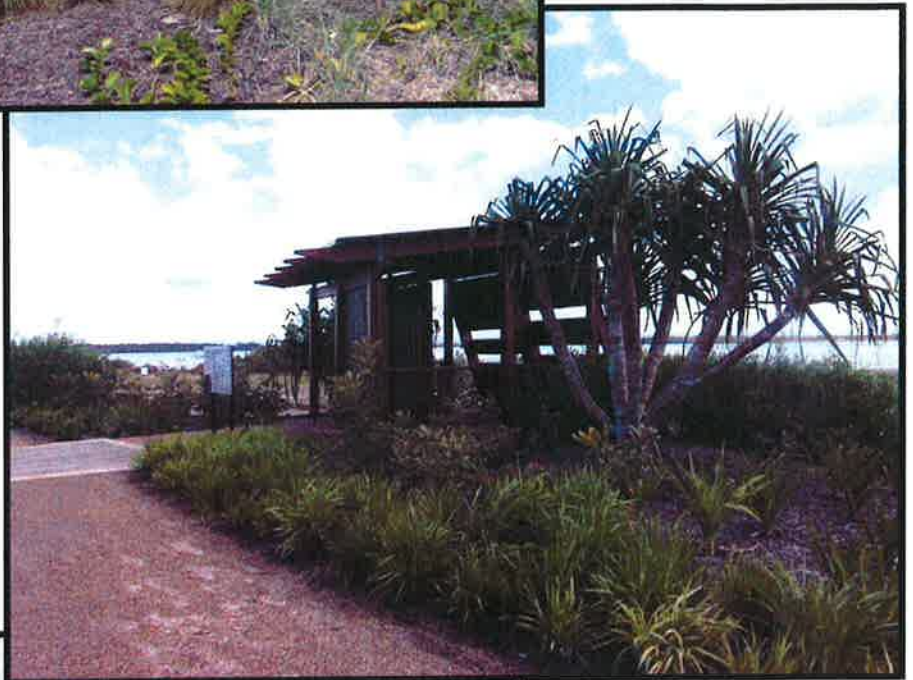
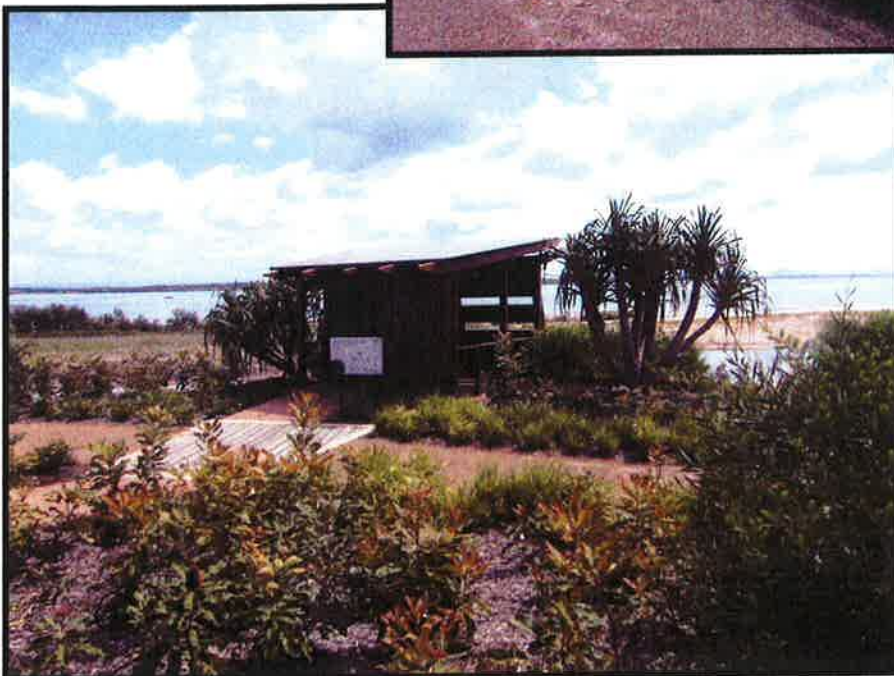
Plate 13. Bird hides at
the northern and
southern end of the
site.

Issue	Procedure
Bird hides	<ul style="list-style-type: none"> • See Plate 13. See Figure 1.2. • Timber is seasoned hardwood of single species F17, durability class 1 and painted with 2 coats of clear finish coating. • Any replacement of metal in the hides is to be 'Dymon 10' coated and painted Olive Ochre – Code P16.C7. • Timber shafts are painted Olive Ochre – Code P16.C7.
Signage	<ul style="list-style-type: none"> • Two signs are from the Queensland Parks and Wildlife Service (shorebird information signs – See Plate 14), the remainder are Caboolture Shire Council signs (e.g. no dogs allowed). See Plate 2. • Site entry signs were custom made. See Plate 15. • Poles for all signs are to be powder coated black.
Roof and guttering on bird hides/interpretive exhibits	<ul style="list-style-type: none"> • Roofing is corrugated aluminium – colour bonded to reduce reflection. • Runoff from guttering is to overflow to rocked areas – not mulched areas. See Plate 16.

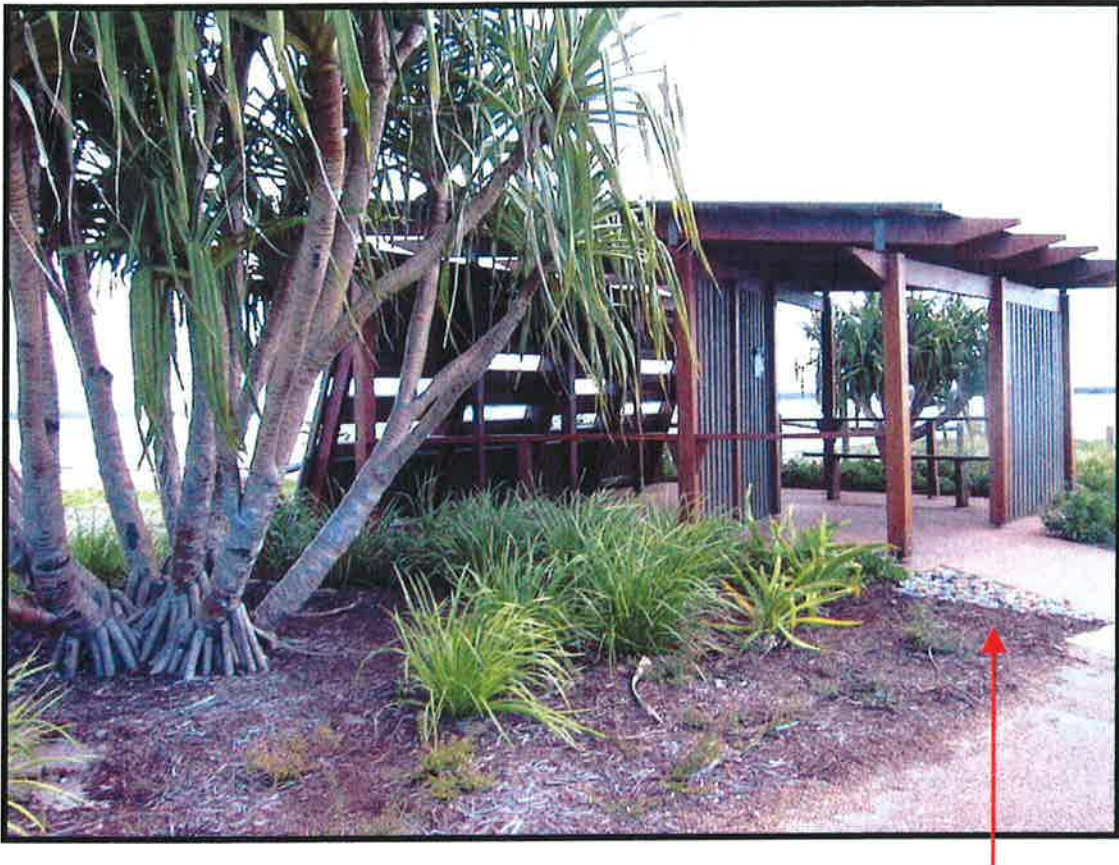
Plate 16. Rocks at base of gutter overflow to minimise erosion from runoff. Bird hide at northern end of site.
